### **CPT2760**

Prepared for: Han-Cock Trading and Projects

DEGREE OF CONFIDENTIALITY	Confidential			
TERMS AND CONDITIONS (Please refer to the full set of terms and conditions as recorded on the quotation sheet)	1. The results of this project and / or the CPT staff are not available for any legal proceedings unless thus arranged prior to the contracting of this project.  2. The results and conclusions of the report/test certificate are made to the highest standards, however the Centre for Polymer Technology (Pty) Ltd cannot be held liable for any losses or damages that may result from the use of the contents of the report.  3. If published or reproduced by a client, a test report/test certificate shall be reproduced in full; CPT reports/test certificates may not be reproduced in part.			
TITLE	UV testing of materials exposed to sunlight SANS 151			
AUTHOR	NAME SIGNATURE

Centre for Polymer Technology (Pty) Ltd were approached by Andrew Enslin from Han-Cock Trading and Projects to test the LNB Protector which is exposed to sunlight.

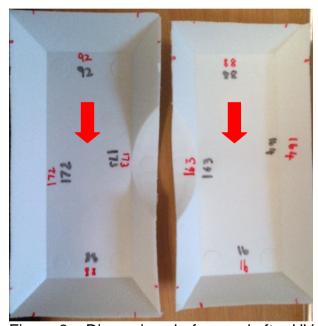
Figure 3 – Dimensions before and after UV

SAMPLE	TEST METHOD	RESULT
LNB Protector	ASTM G154 for 240hours.	No colour changes, or dimensional changes (shrinkage) occurred after the accelerated weathering.

UV weathering the part under the conditions of ASTM G154 at 240 hours did not show any signs of discolouration, breaking or cracking when impacted. Refer to figures 2 and 3.
